REPEATED LOADS ABOVE THE PROPORTIONAL LIMIT  
ON 24ST ALUMINUM ALLOY

Thesis by

In Partial Fulfillment of  
The Requirements for the Professional  
Degree in Aeronautical Engineering

1947

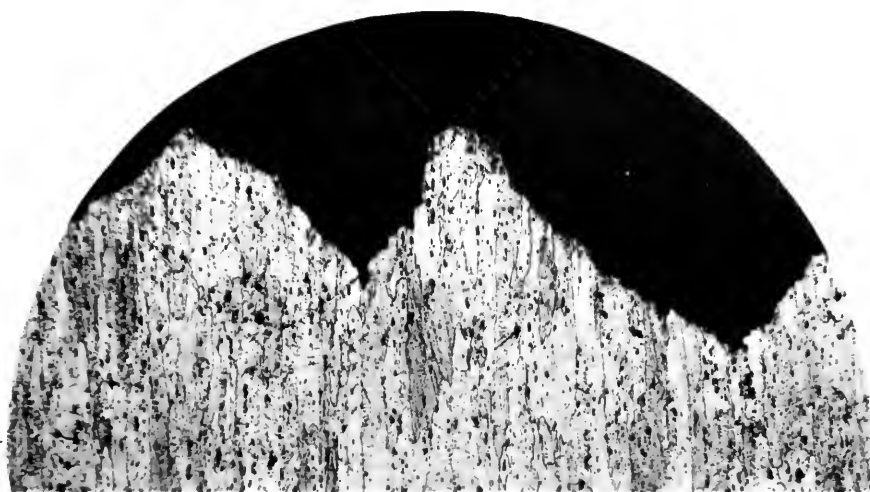
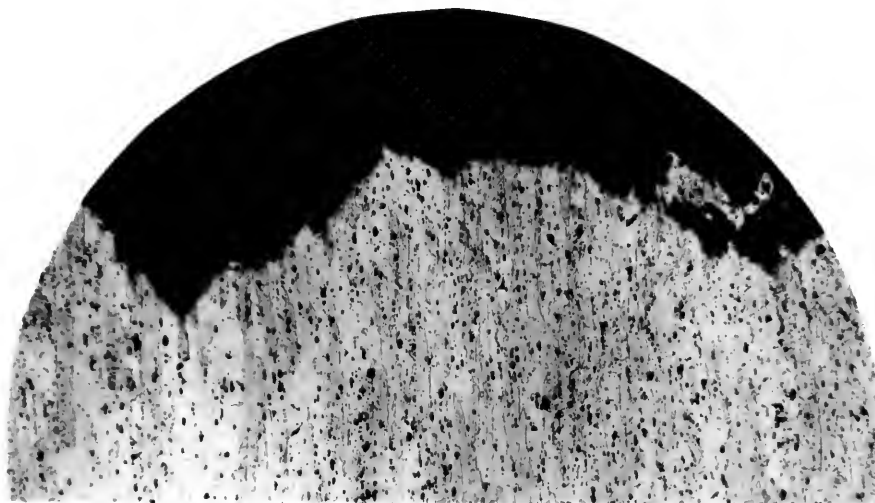
No. 4  
(220 cycles)

No. 3  
(1200 cycles)

No. 5  
(4050 cycles)

Fig. 19  
Effect of Varying Numbers of Cycles  
at Same Stress (68,100 p.s.i.)  
Mag. 50 dia. Etch: Keller

Three more specimens were subjected to runs at 68,100 psi. (just below the ultimate strength) and fractured at widely varying numbers of cycles. Photomicrographs of their fractures appear in Fig. 19.

varying values of stress cycles although they were from the same batch of material and were worked at the same stress, the question arose as to whether there might be internal evidence to indicate the reason. Hence photomicrographs were made of the fractured specimens. Fig. 19 shows the profiles of the fractures and the adjacent grain structure. As might be expected, the fracture profiles show the increase in brittleness with increase in number of applied cycles. However, the grain structures are essentially the same and yielded no clue beyond showing grain orientation in the direction of the applied stress which was to be expected. Fig. 20 is a photomicrograph of the same three specimens in a low stress region and here again is barren of results beyond showing that the grain structure of all are practically identical.
